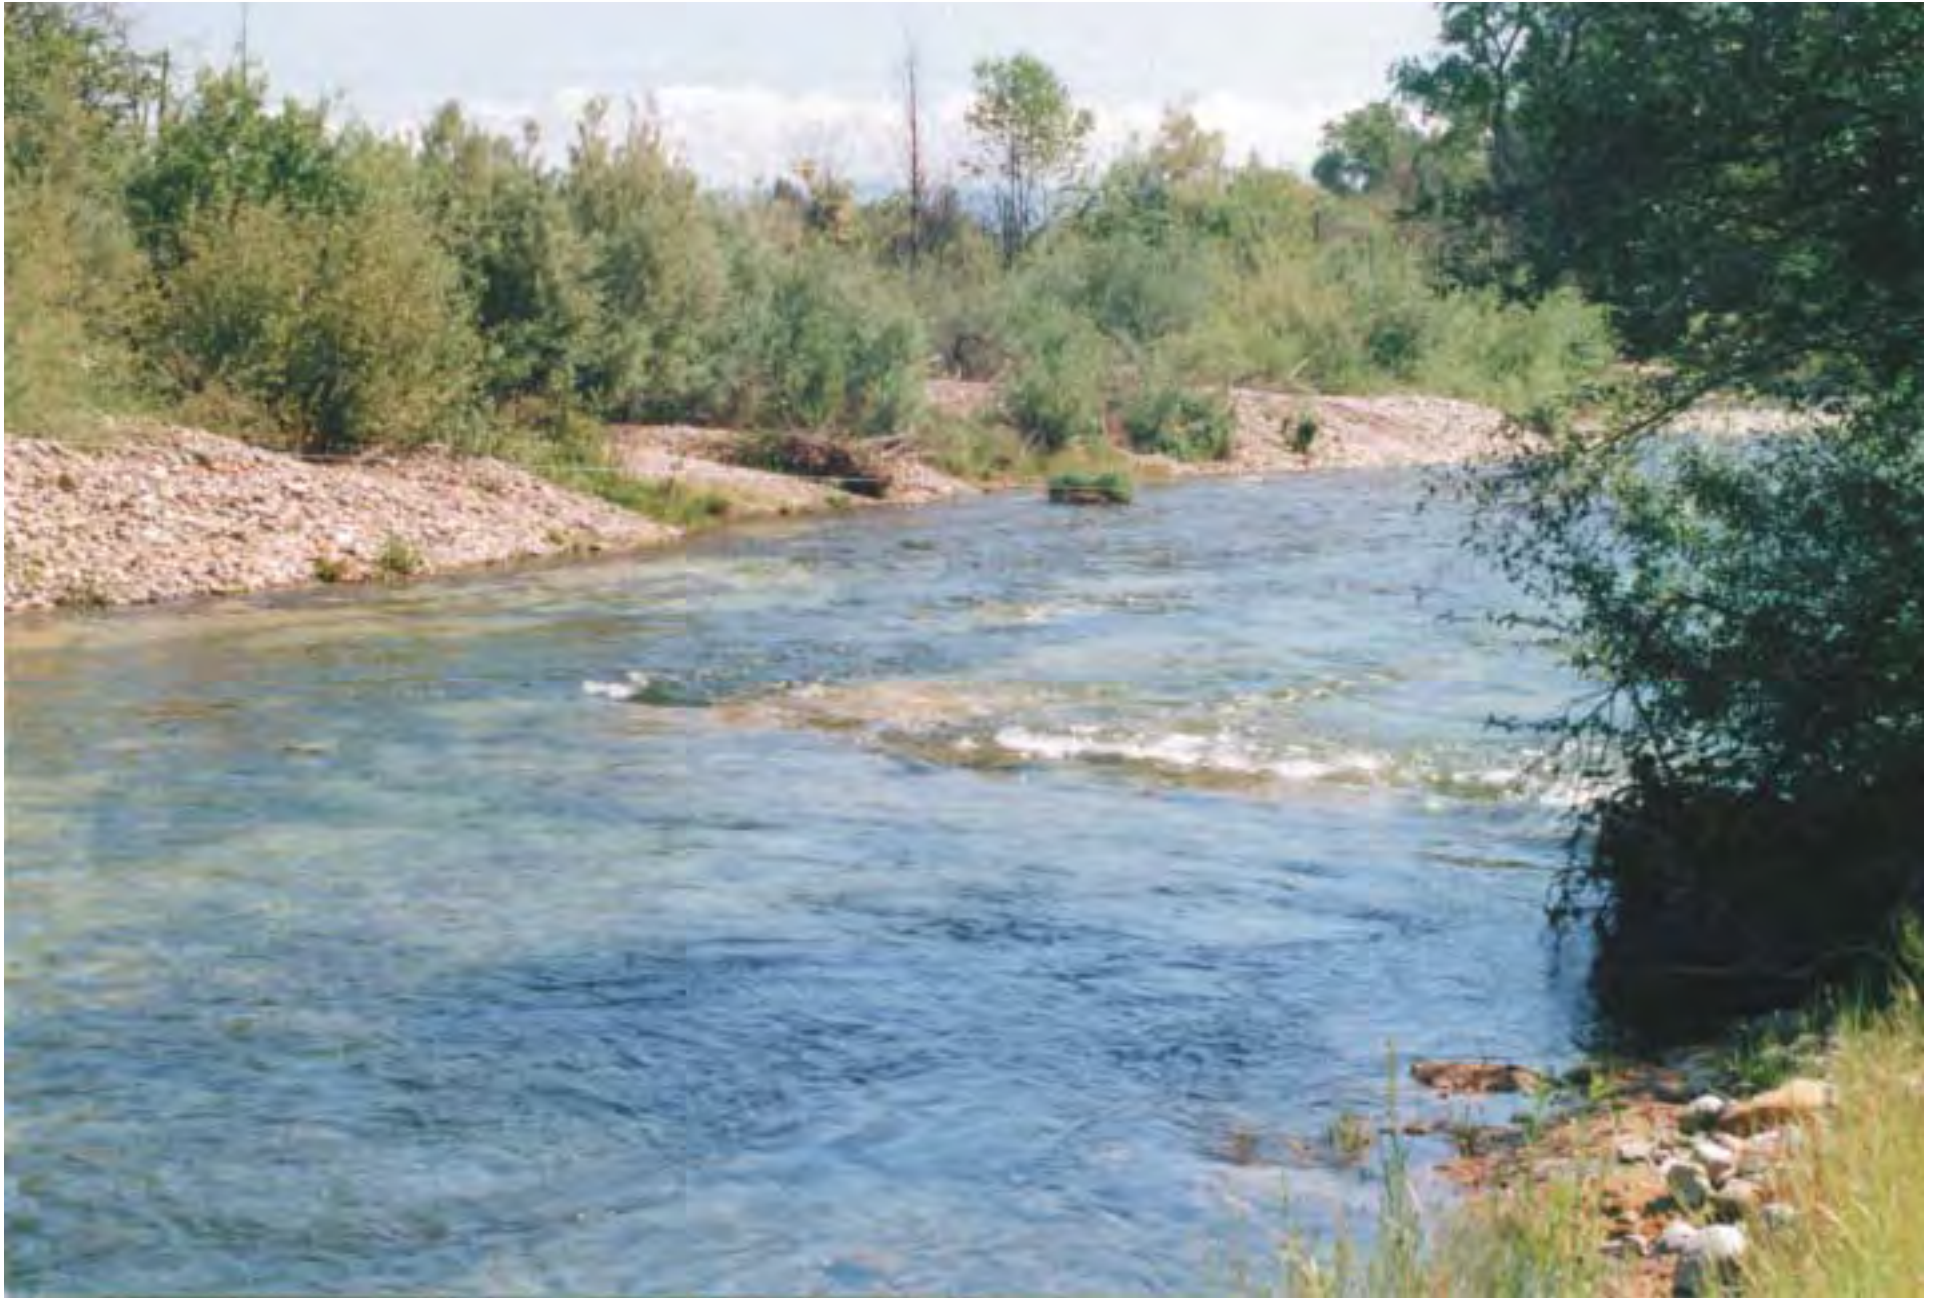
Figure 3 - Photo of Clear Creek along the project reach, showing most of the channel bed surface is exposed clay hardpan.
